June 28, 2019
File No. 262018.063

Subject: Department of Natural Resources Washington Geological Survey,
School Seismic Safety Assessment Project, Contract No. AE 410 -
Seismic Evaluation for **Longview School District**

School Buildings Evaluated in the Longview School District

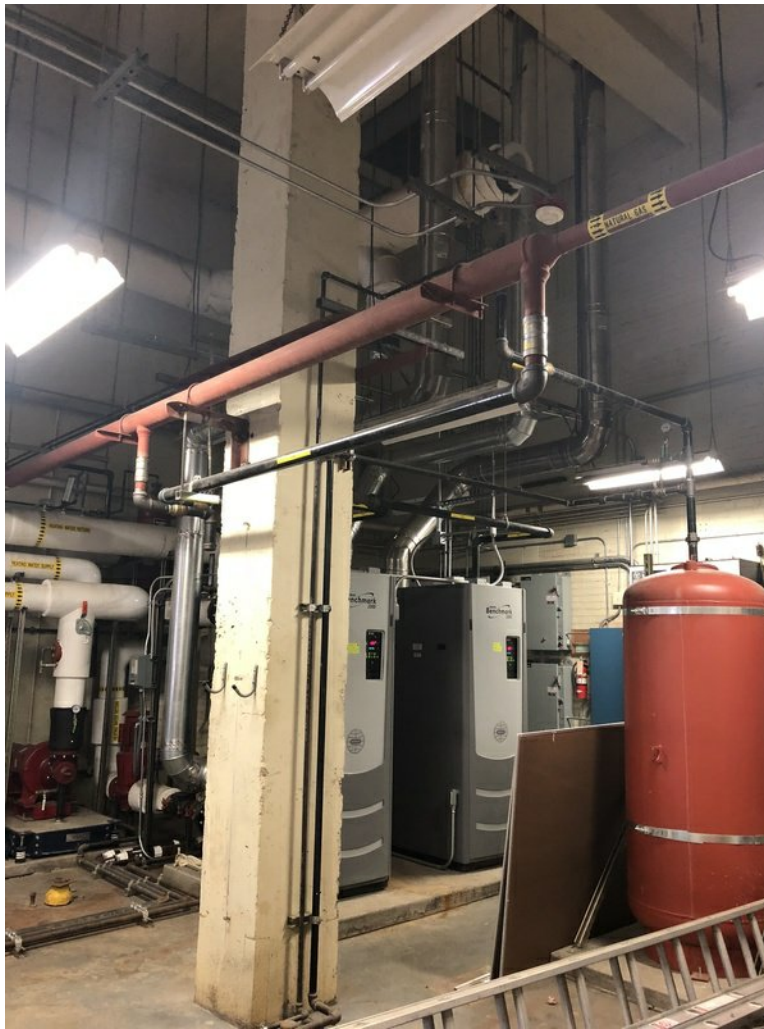
Figure 1-10. Boiler Room with Unbraced Nonstructural Components

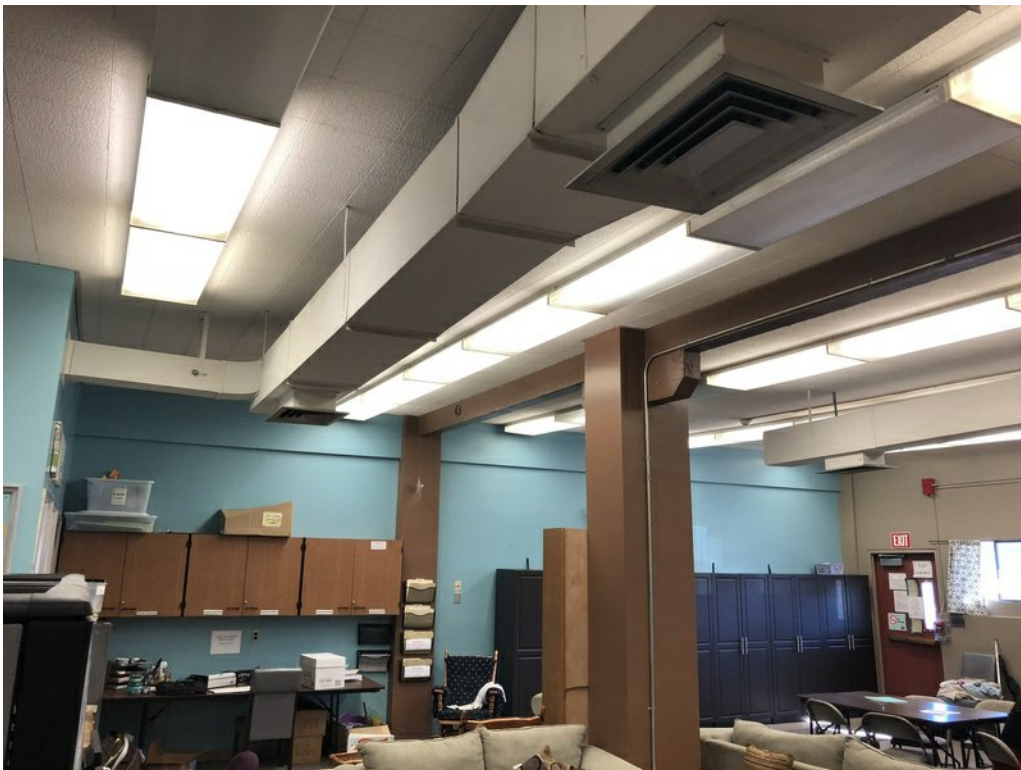
Figure 1-7. Interior Showing Suspended Mechanical Equipment and Wood Beam Framing

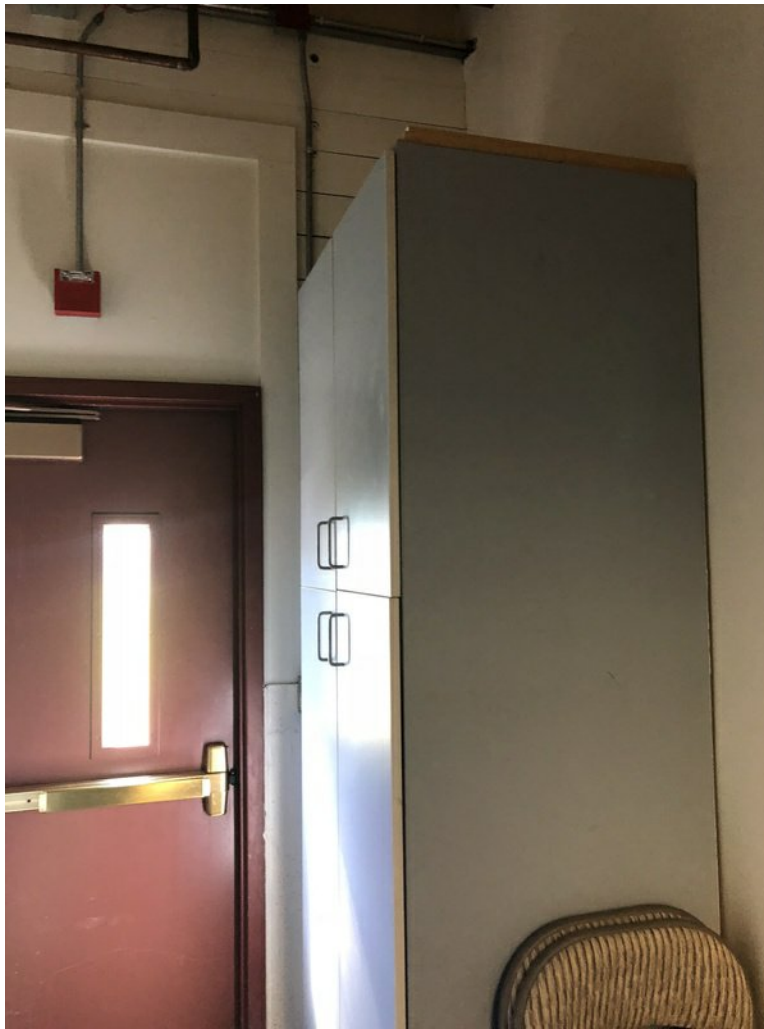
Figure 1-10. Tall Unbraced Nonstructural Components, Typical Throughout

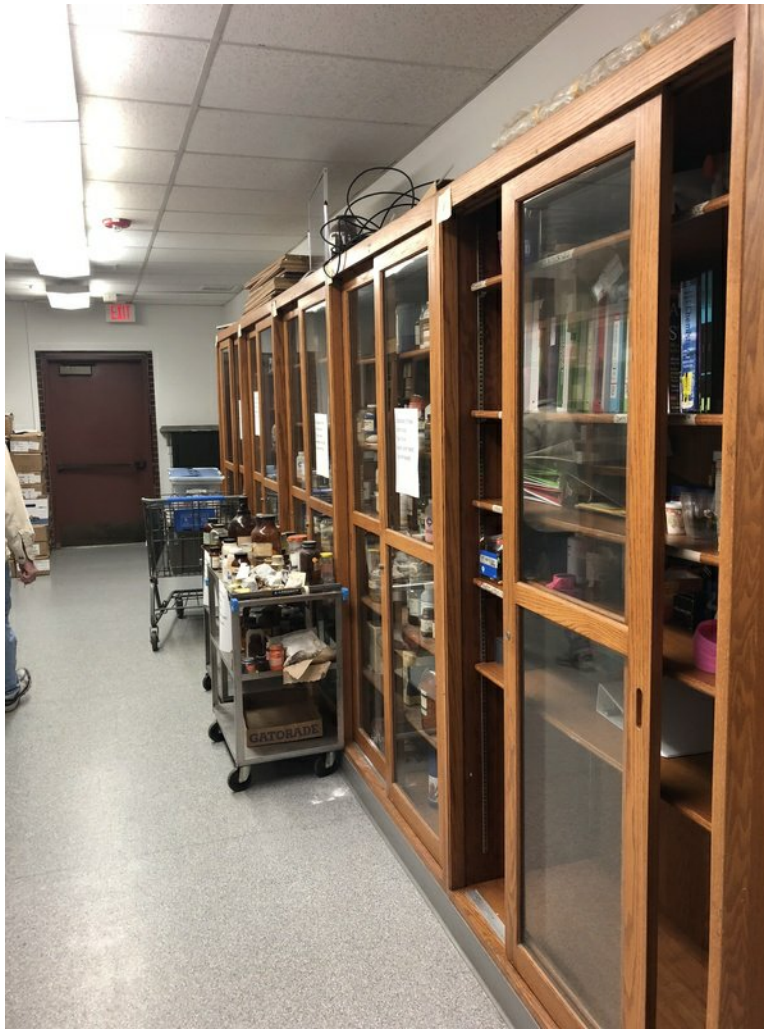
Figure 1-9. Tall Unbraced Nonstructural Components, Typical Throughout

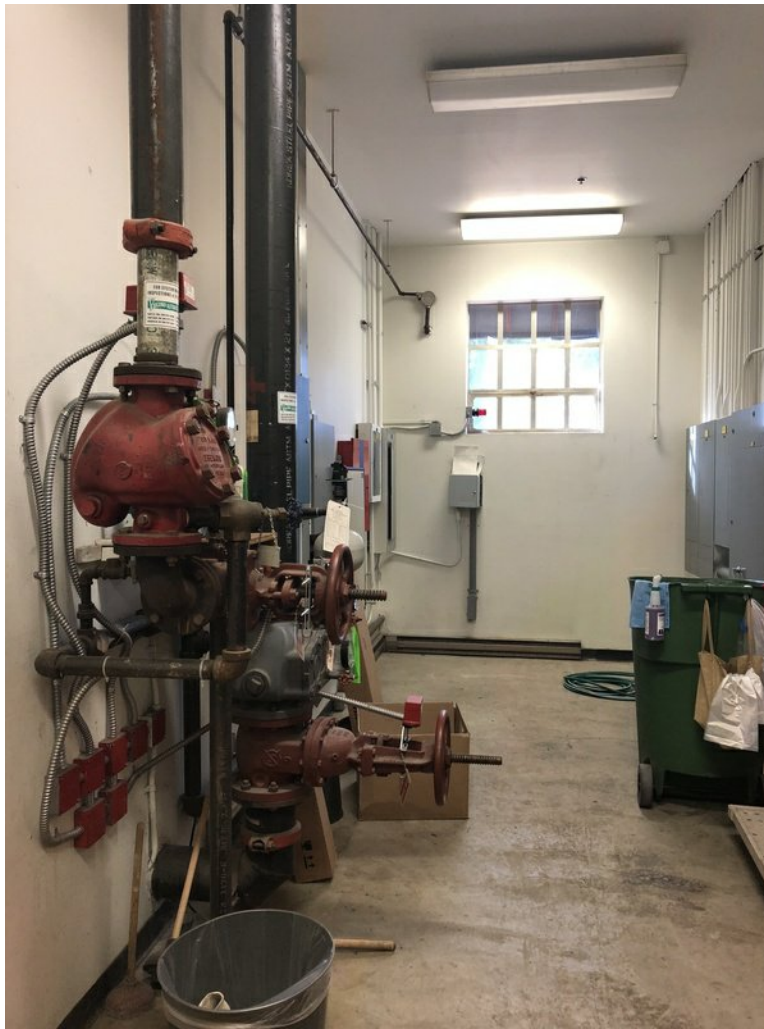
Figure 1-10. Fire Riser and Fire Suppression Piping Should Be Braced
